FIGURE 6
Existing and Proposed Conditions
Depth at 701 cfs (5-year Flow)
 Coppei Creek Project Area 07 30% Design
 for Walla Walla County Conservation District

FIGURE 15
Existing and Proposed Conditions
Velocity at 1002 cfs (10-Year Recurrence)
 Coppei Creek Project Area 07 30% Design
 for Walla Walla County Conservation District

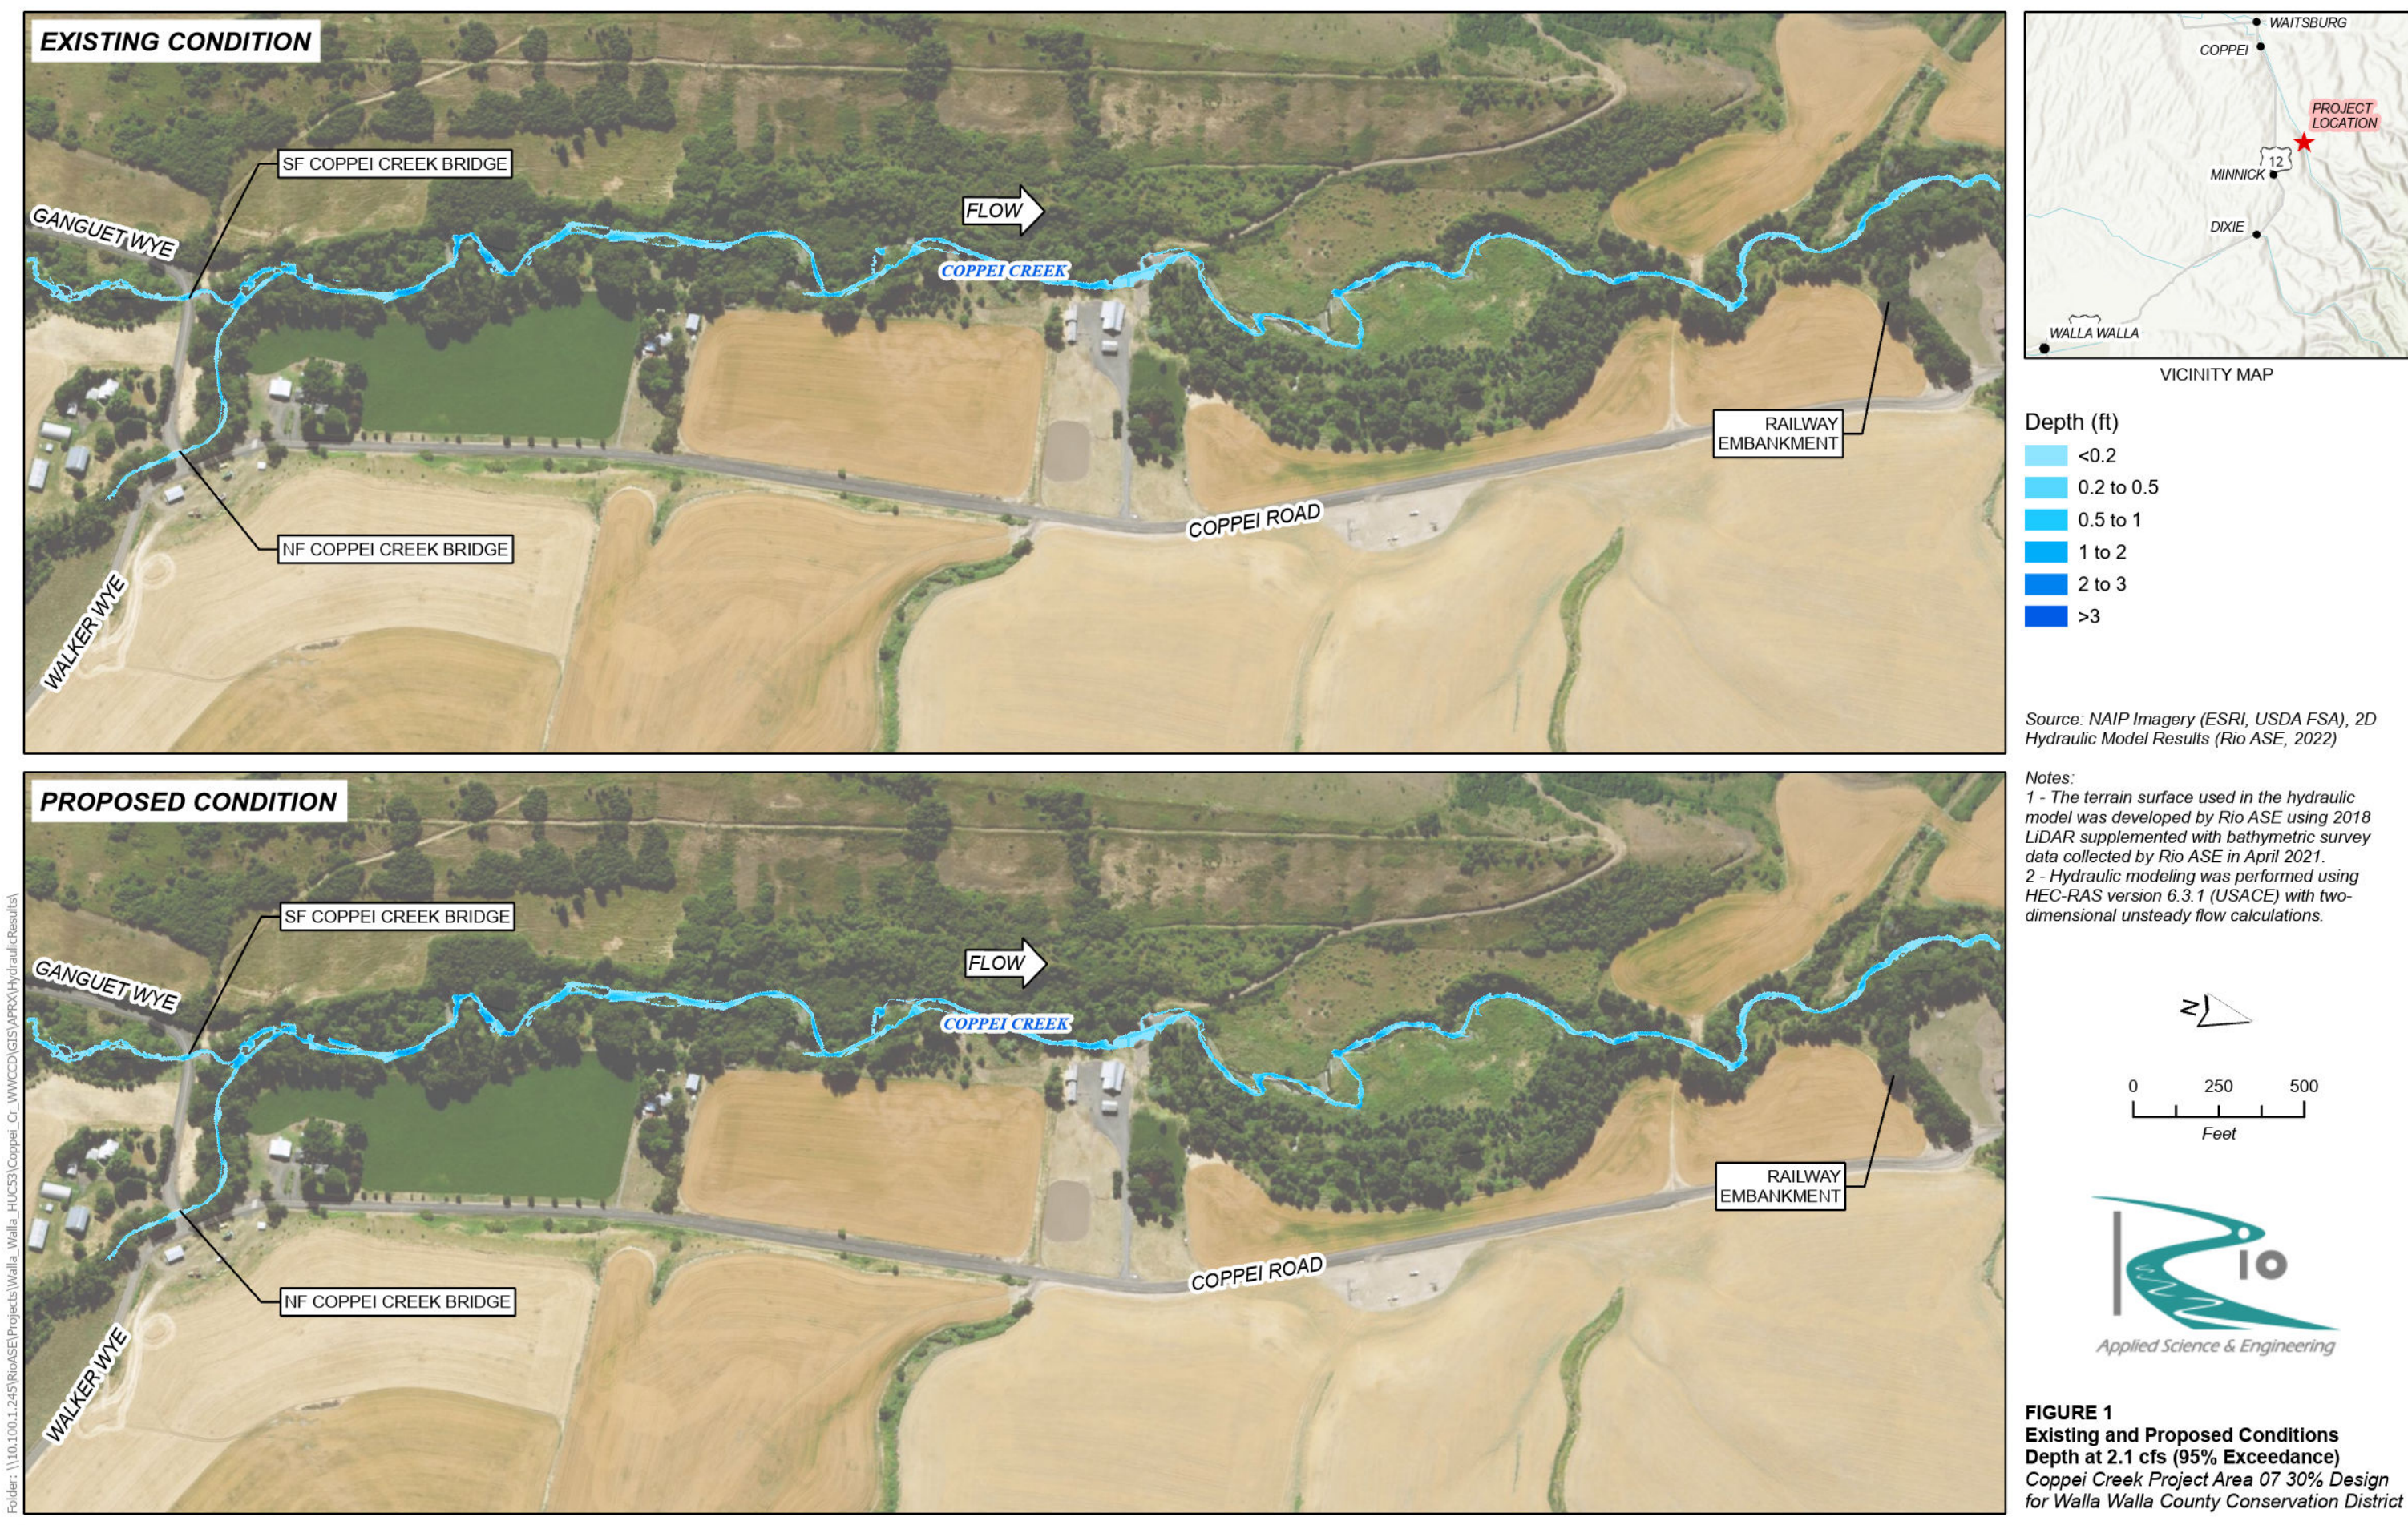
Notes:
 1 - The terrain surface used in the hydraulic model was developed by Rio ASE using 2018 LiDAR supplemented with bathymetric survey data collected by Rio ASE in April 2021.
 2 - Hydraulic modeling was performed using HEC-RAS version 6.3.1 (USACE) with two-dimensional unsteady flow calculations.

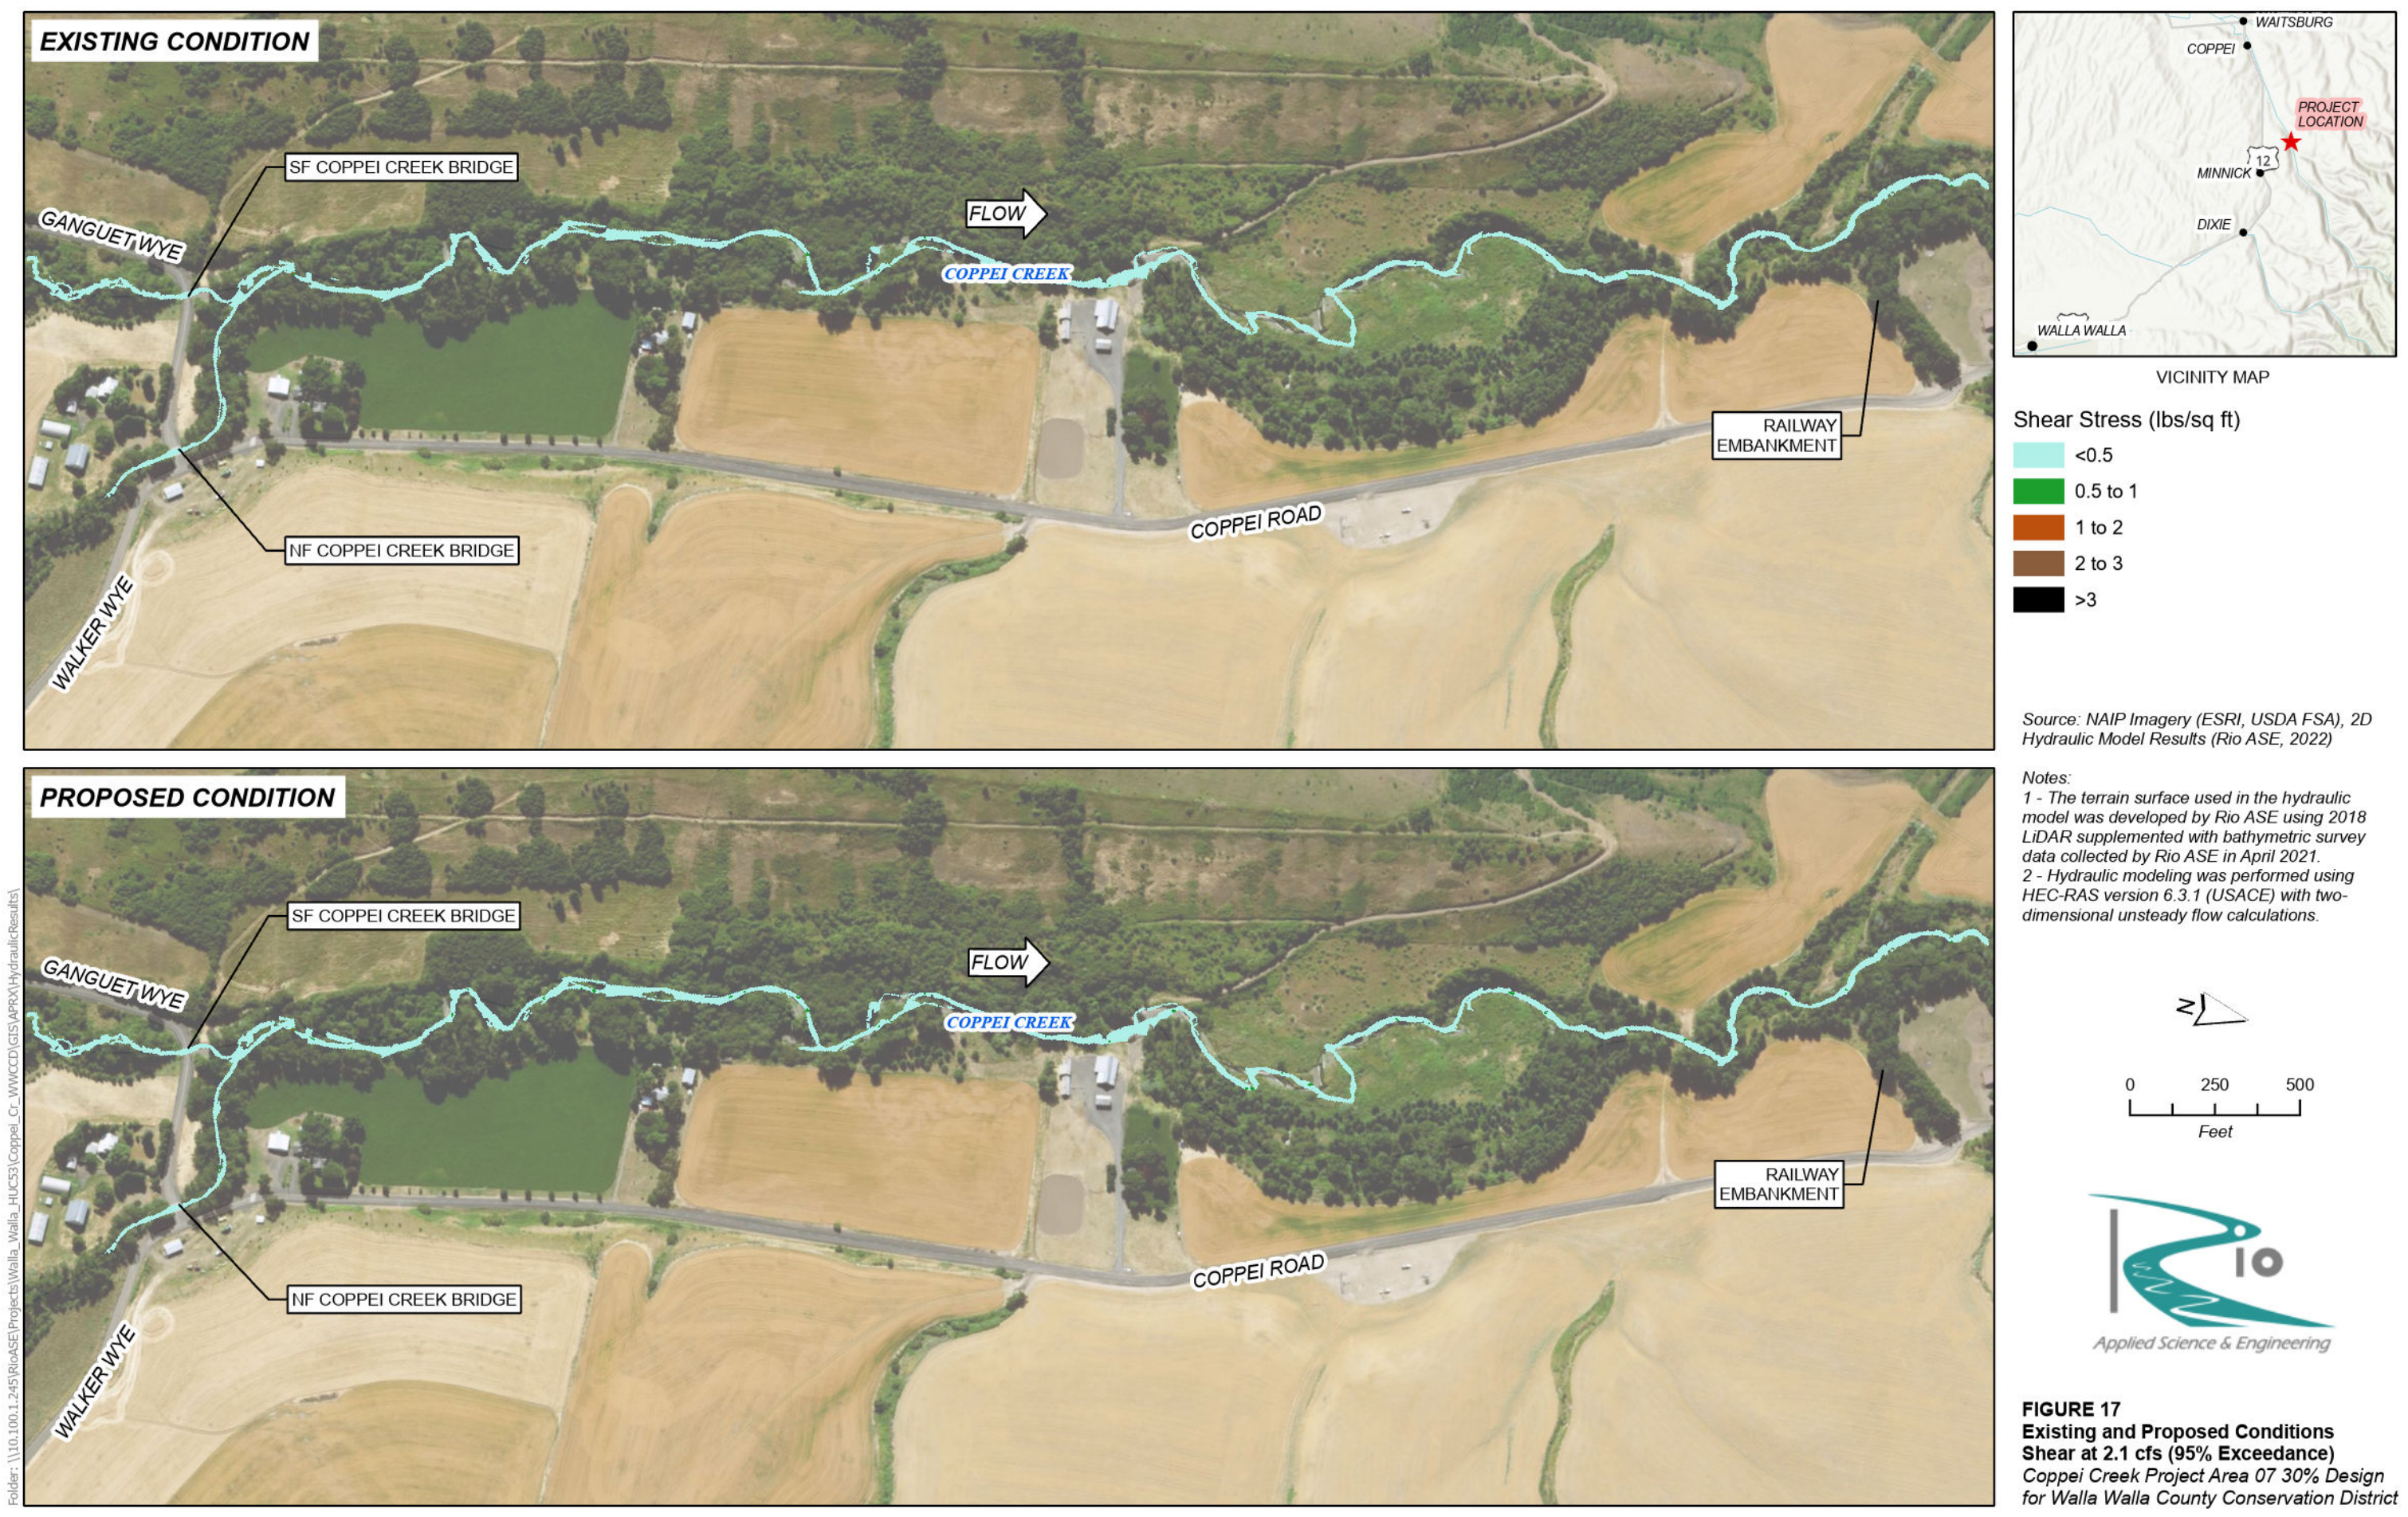
Shear Stress (lbs/sq ft)

Notes:
 1 - The terrain surface used in the hydraulic model was developed by Rio ASE using 2018 LiDAR supplemented with bathymetric survey data collected by Rio ASE in April 2021.
 2 - Hydraulic modeling was performed using HEC-RAS version 6.3.1 (USACE) with two-dimensional unsteady flow calculations.

FIGURE 18
Existing and Proposed Conditions
Shear at 8.7 cfs (50% Exceedance)
 Coppei Creek Project Area 07 30% Design
 for Walla Walla County Conservation District

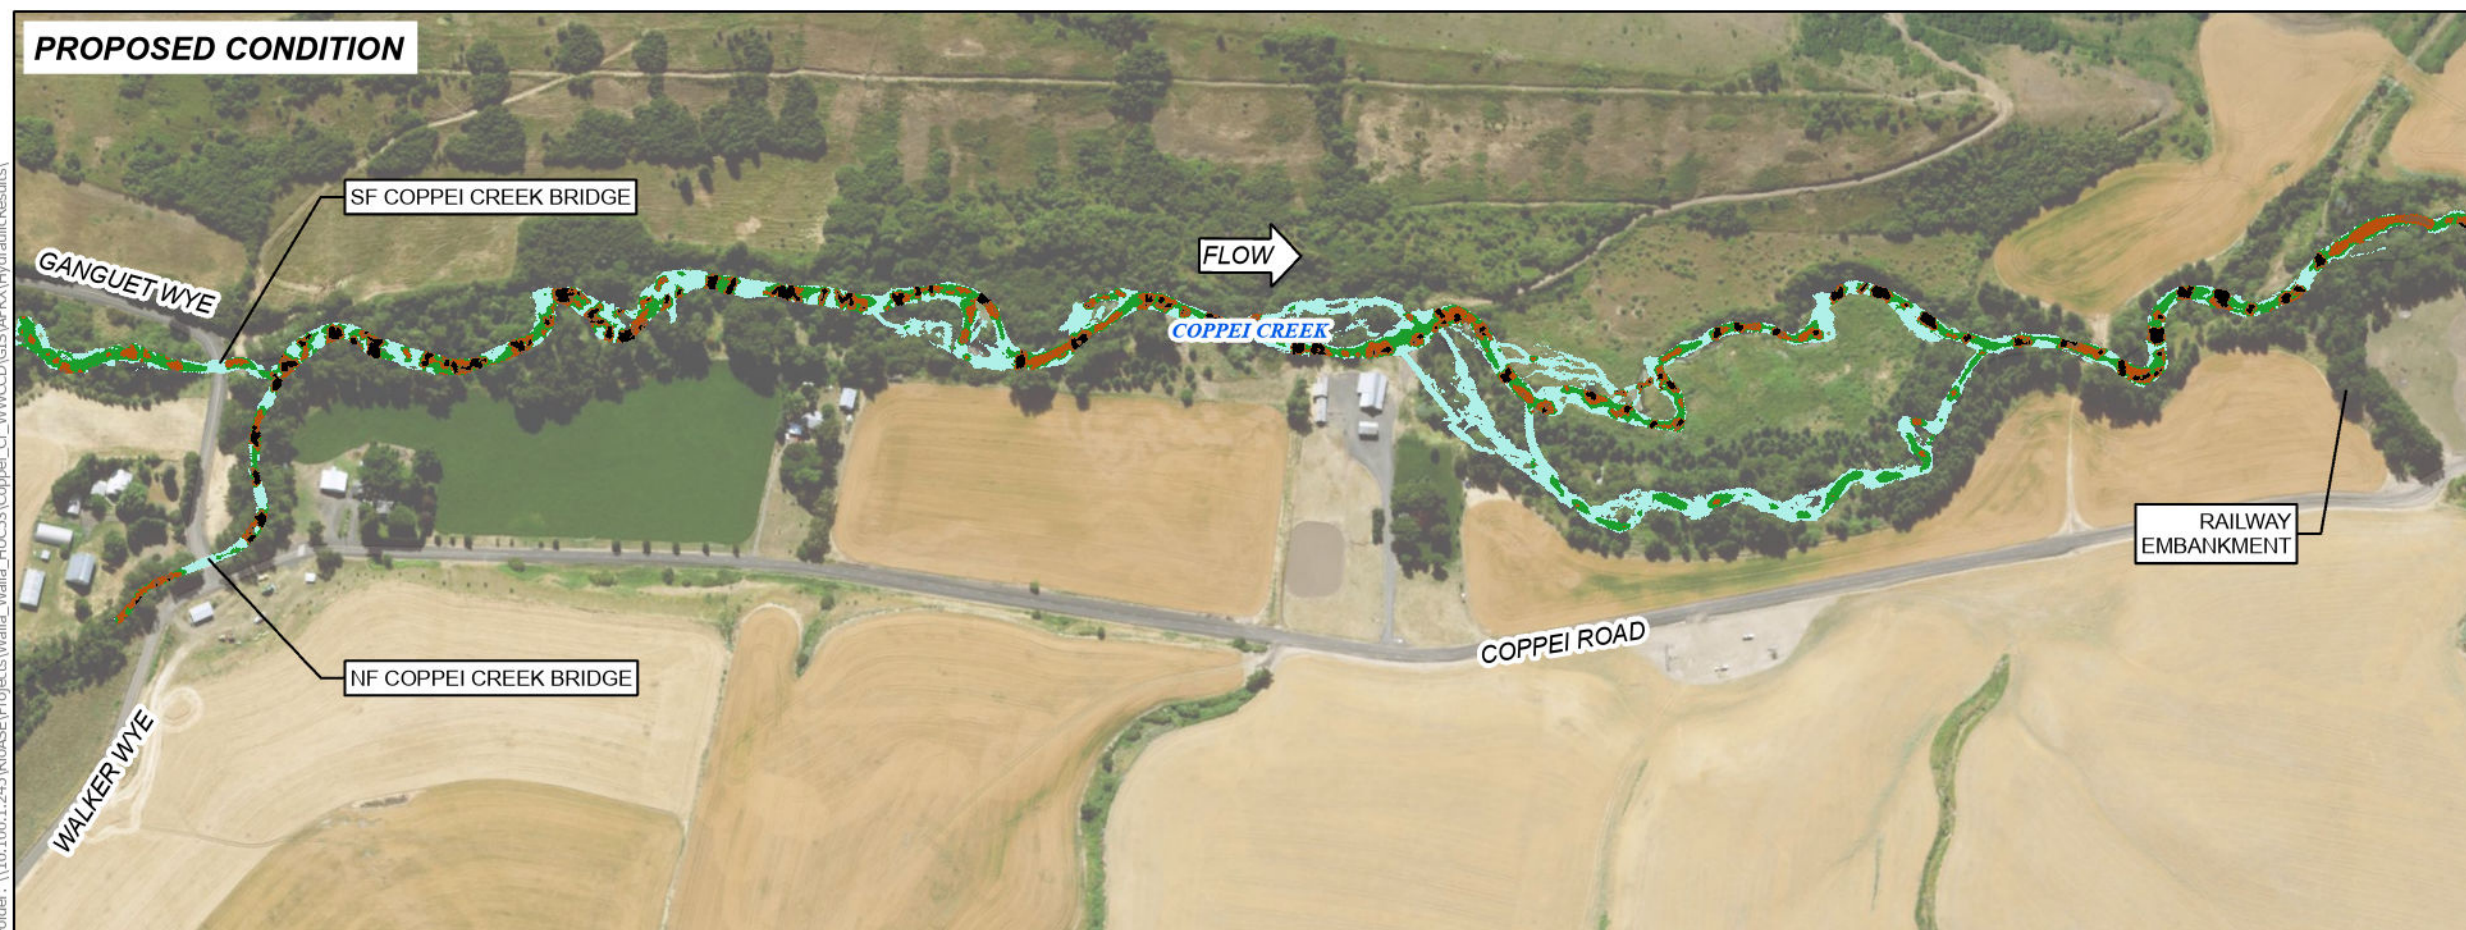
Shear Stress (lbs/sq ft)

Notes:
1 - The terrain surface used in the hydraulic model was developed by Rio ASE using 2018 LiDAR supplemented with bathymetric survey data collected by Rio ASE in April 2021.
2 - Hydraulic modeling was performed using HEC-RAS version 6.3.1 (USACE) with two-dimensional unsteady flow calculations.

FIGURE 20
Existing and Proposed Conditions
Shear at 259 cfs (1.5-Year Recurrence)
Coppei Creek Project Area 07 30% Design
for Walla Walla County Conservation District

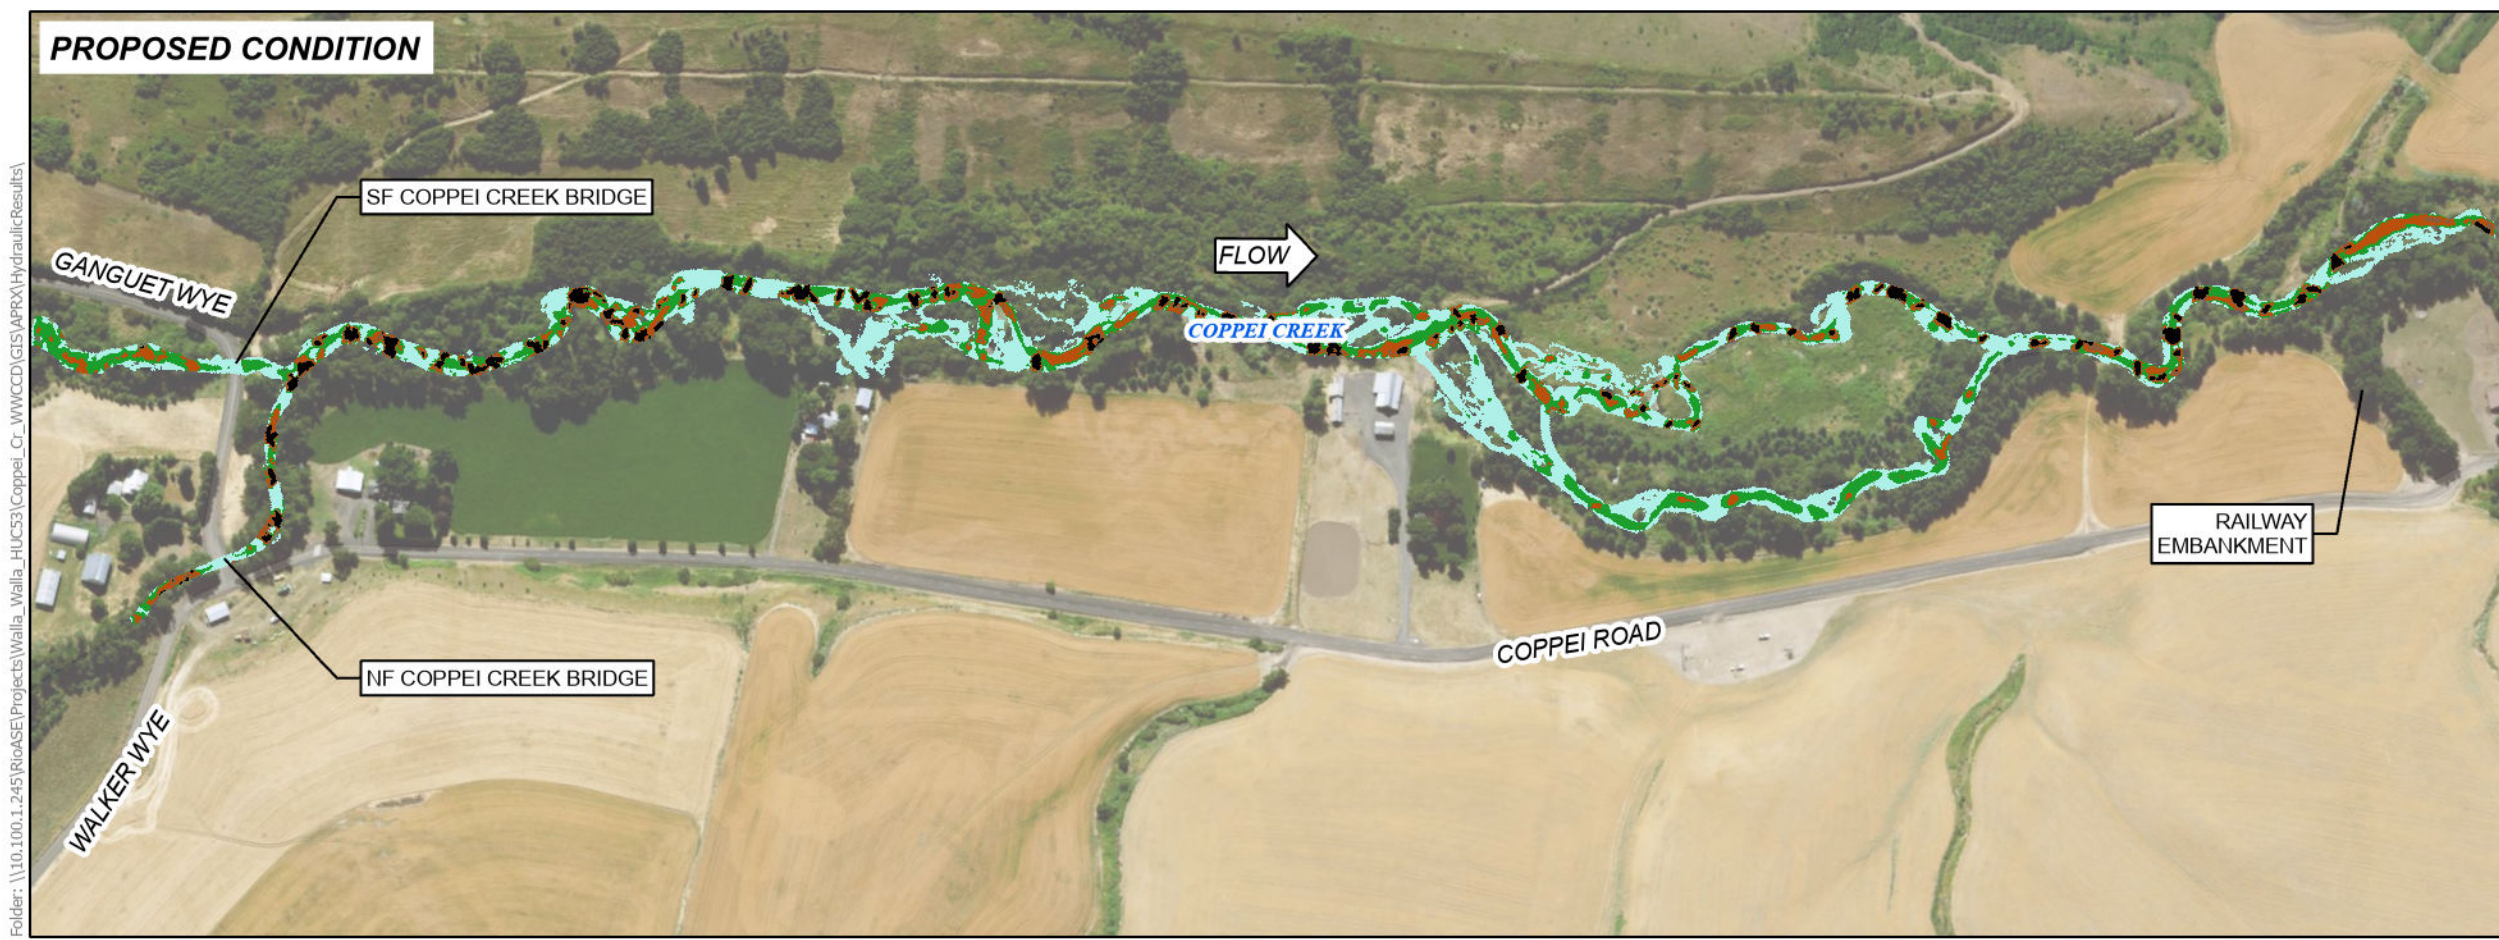
FIGURE 21
Existing and Proposed Conditions
Shear at 361 cfs (2-Year Recurrence)
 Coppei Creek Project Area 07 30% Design
 for Walla Walla County Conservation District

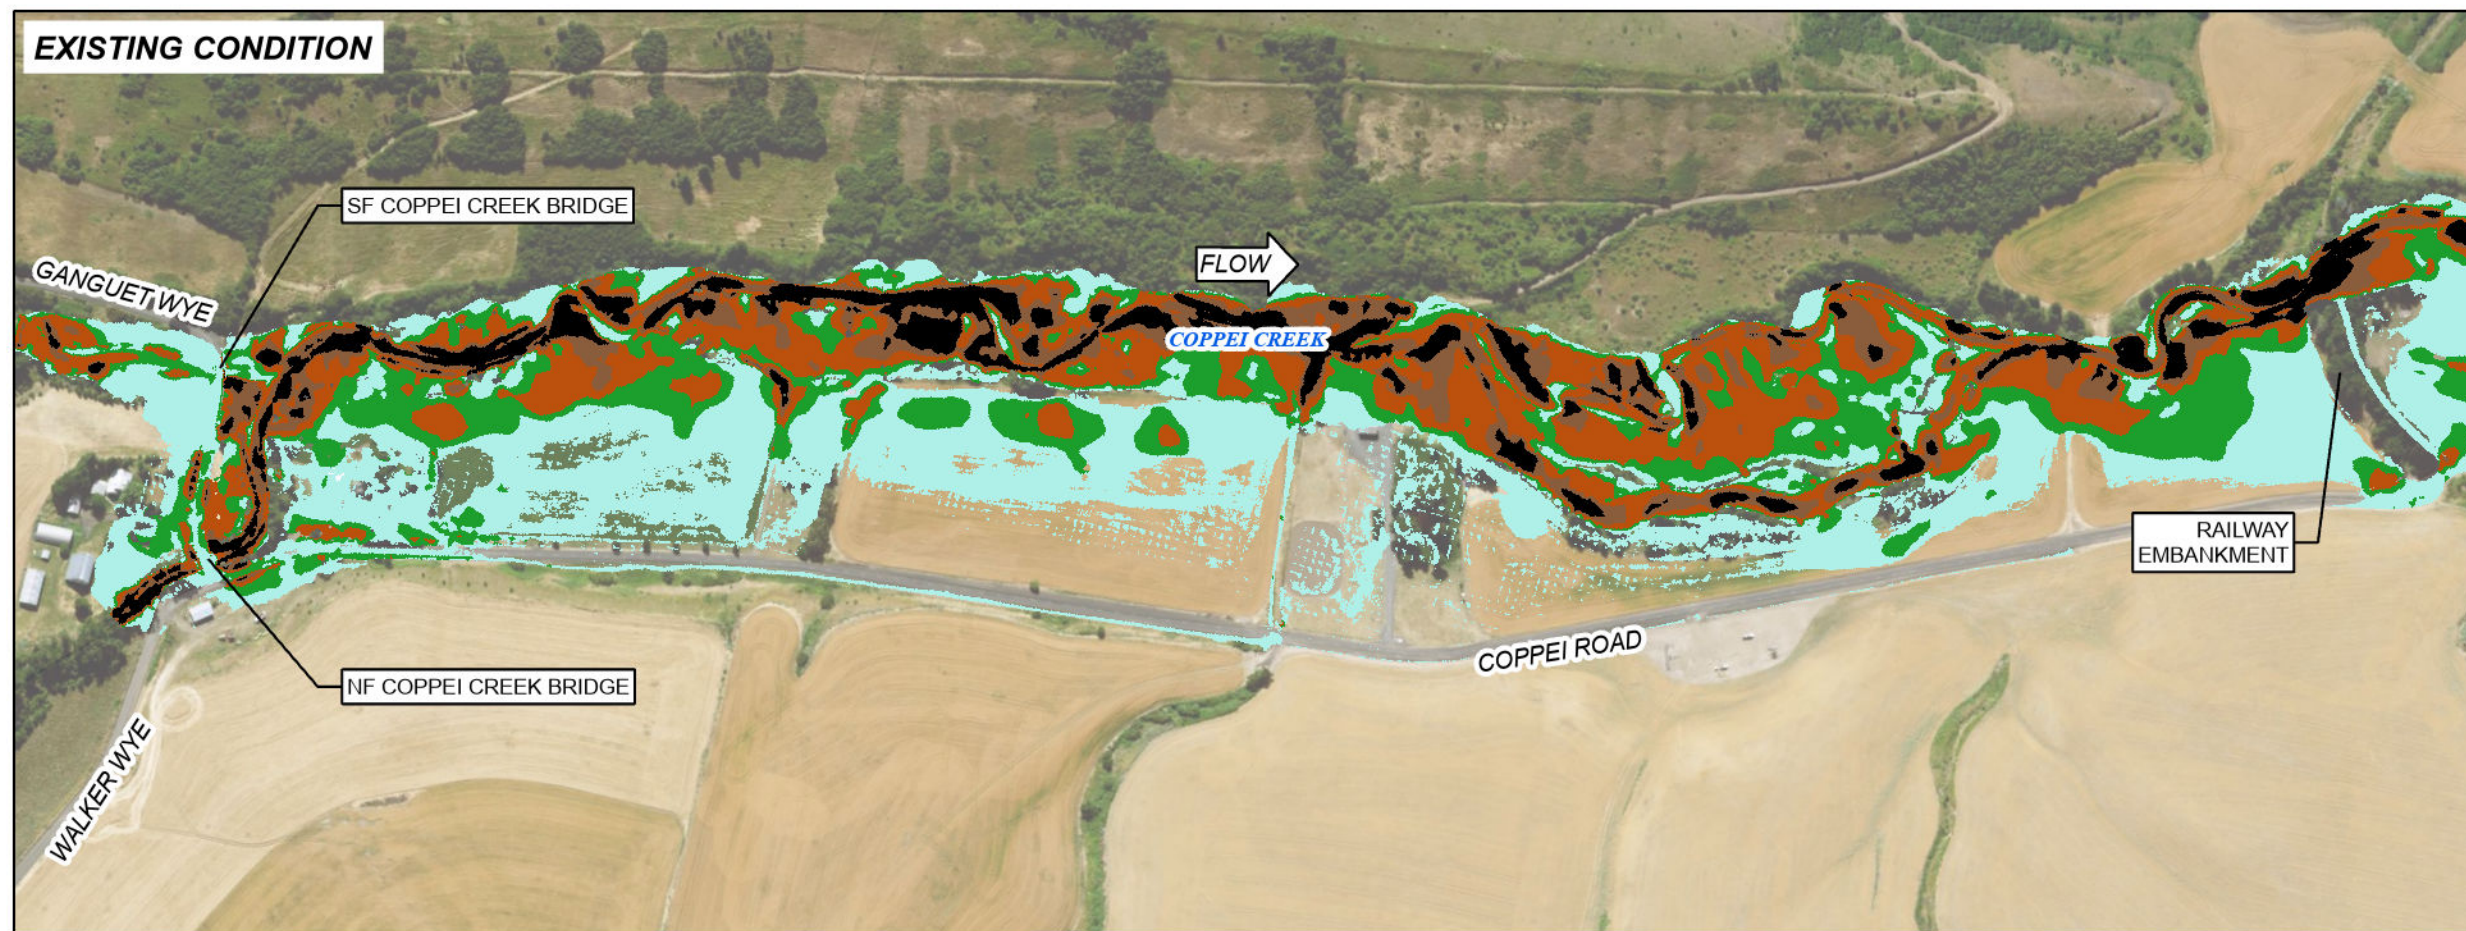
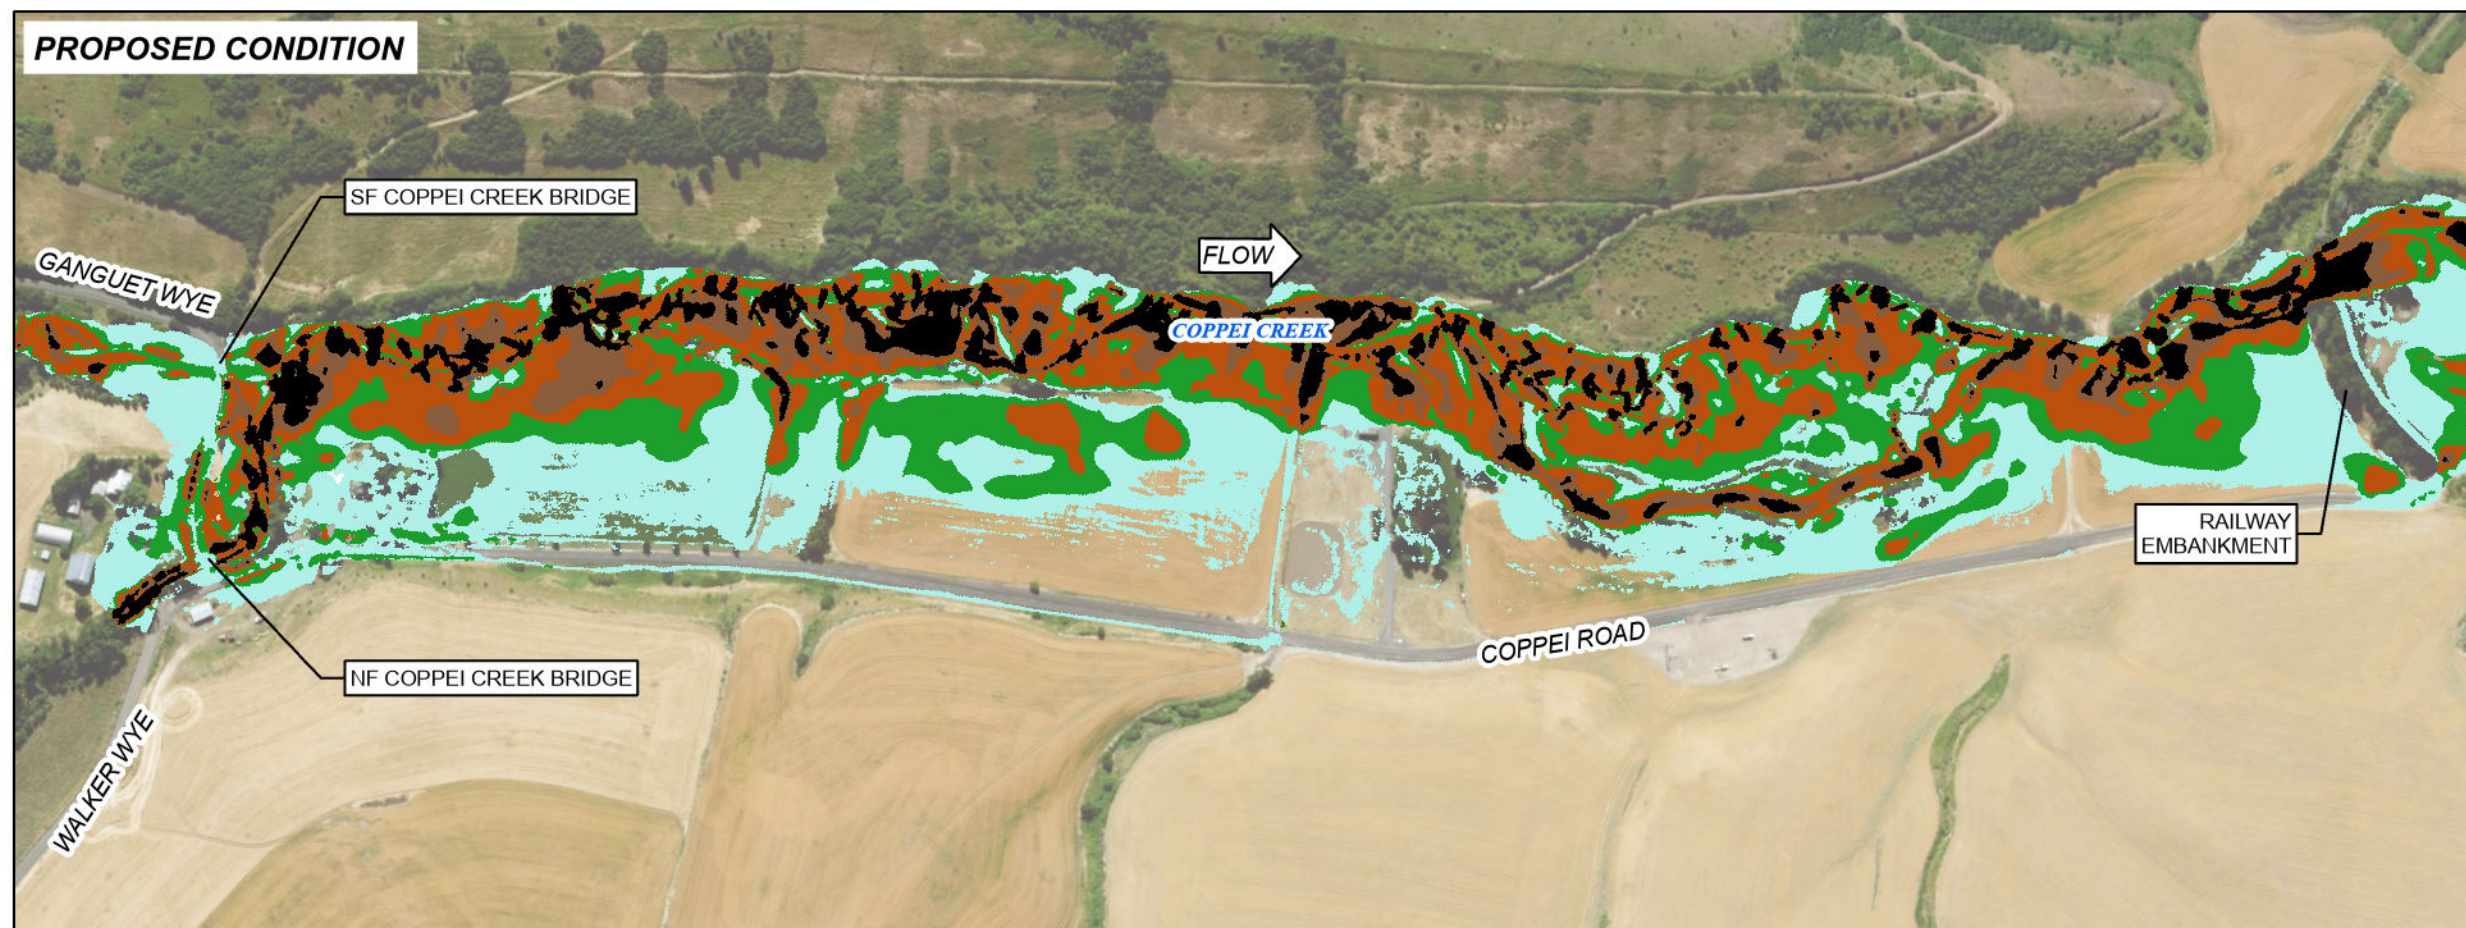
Shear Stress (lbs/sq ft)

1 - The terrain surface used in the hydraulic model was developed by Rio ASE using 2018 LiDAR supplemented with bathymetric survey data collected by Rio ASE in April 2021.

2 - Hydraulic modeling was performed using HEC-RAS version 6.3.1 (USACE) with two-dimensional unsteady flow calculations.

FIGURE 24
Existing and Proposed Conditions
Shear at 2403 cfs (100-Year Recurrence)
Coppei Creek Project Area 07 30% Design
for Walla Walla County Conservation District
